September 1, 2010

**RE: GEOLOGIC RECONNAISSANCE LETTER REPORT**  
**KALA POINT BLUFF (NORTHERN SECTOR)**  
**PORT TOWNSEND, WASHINGTON**

Geologic Reconnaissance  
Kala Point Bluff  
(Northern Sector)  
Port Townsend, Washington

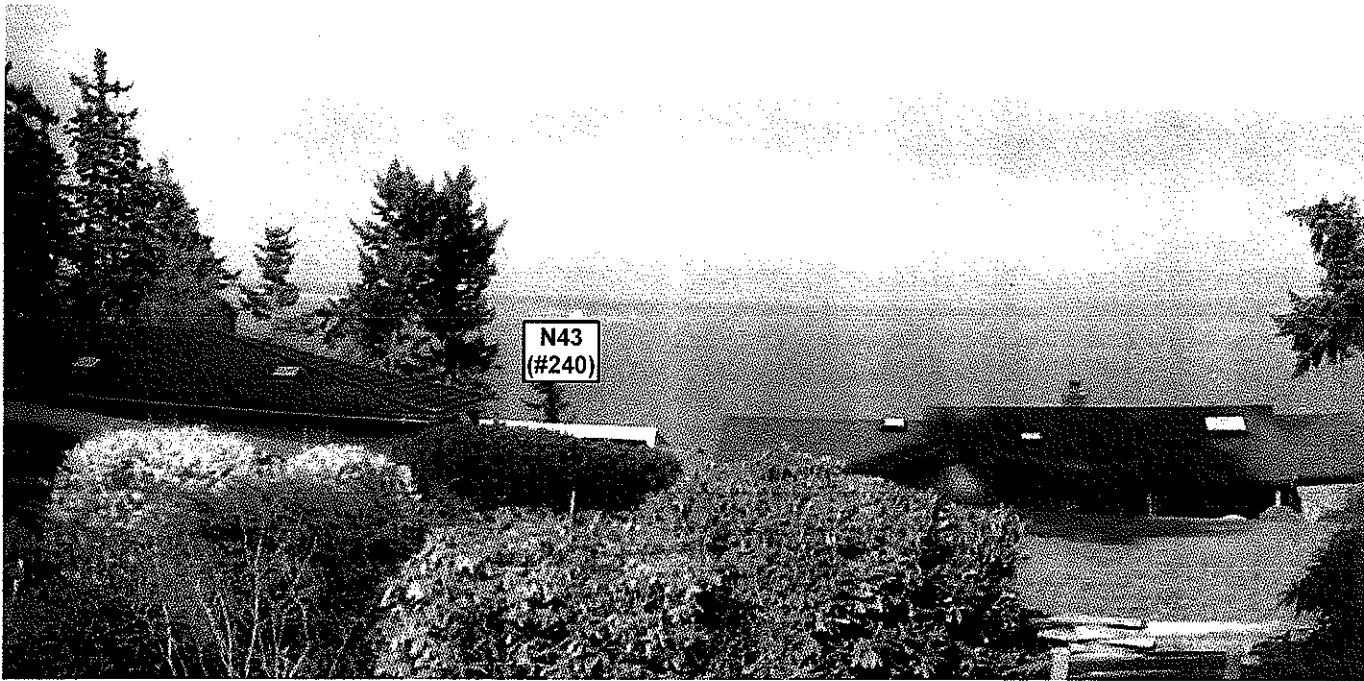
a. Bluff view looking northeast with select trees noted.

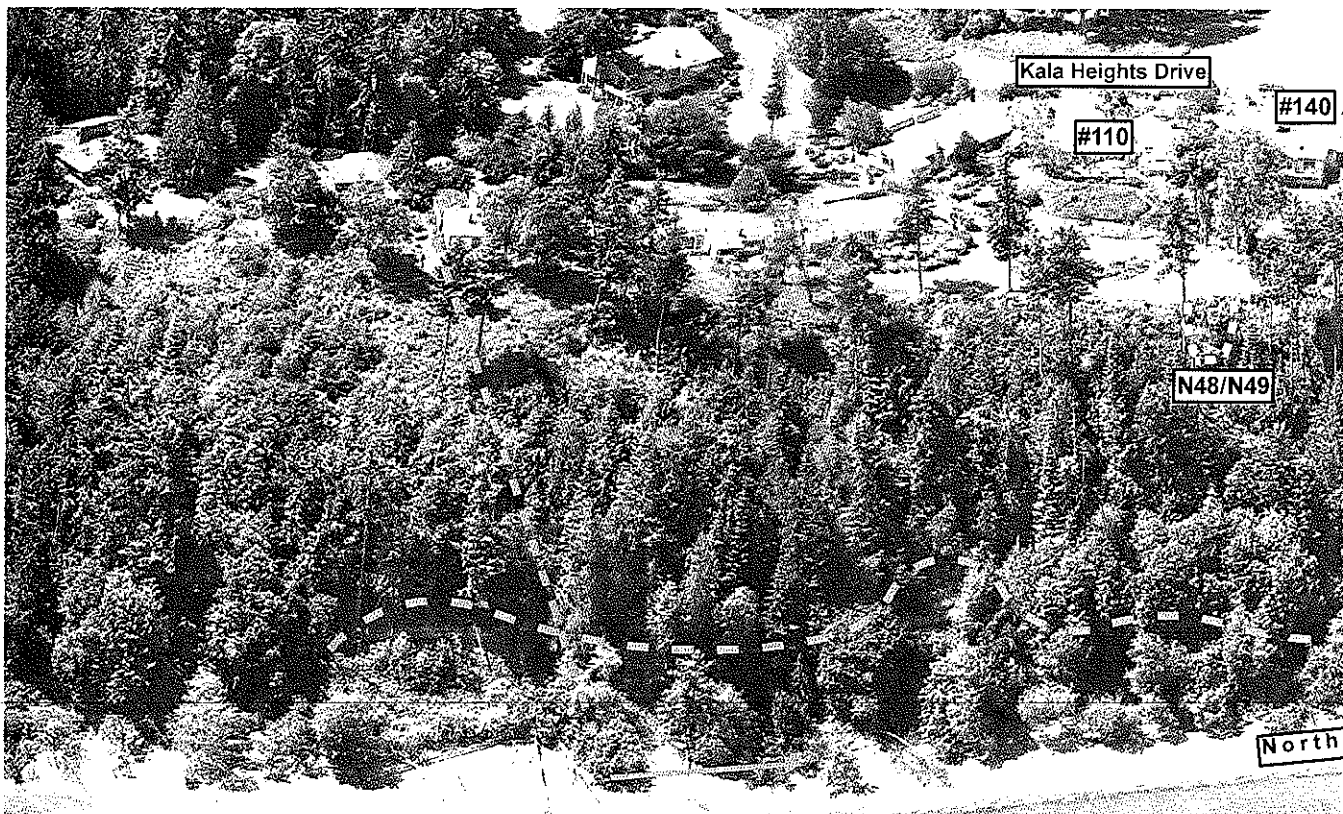
A review of available historical aerial photographs taken in 1994, 2001, and 2006 (WDOE 2010) shows the general bluff area heavily vegetated with no readily visible signs of erosion and/or landsliding with the exception of slope toe erosion (Figure 4). This erosion is typical of Puget Sound coastal bluff areas that develop as a result of continued wave attack, which results in oversteepening of the lower portion of the slope. Undercutting by wave attack and surficial landsliding are the primary mechanisms that contribute to ongoing slope regression.

b. Aerial photograph taken June 30, 2006. View looking southwest.

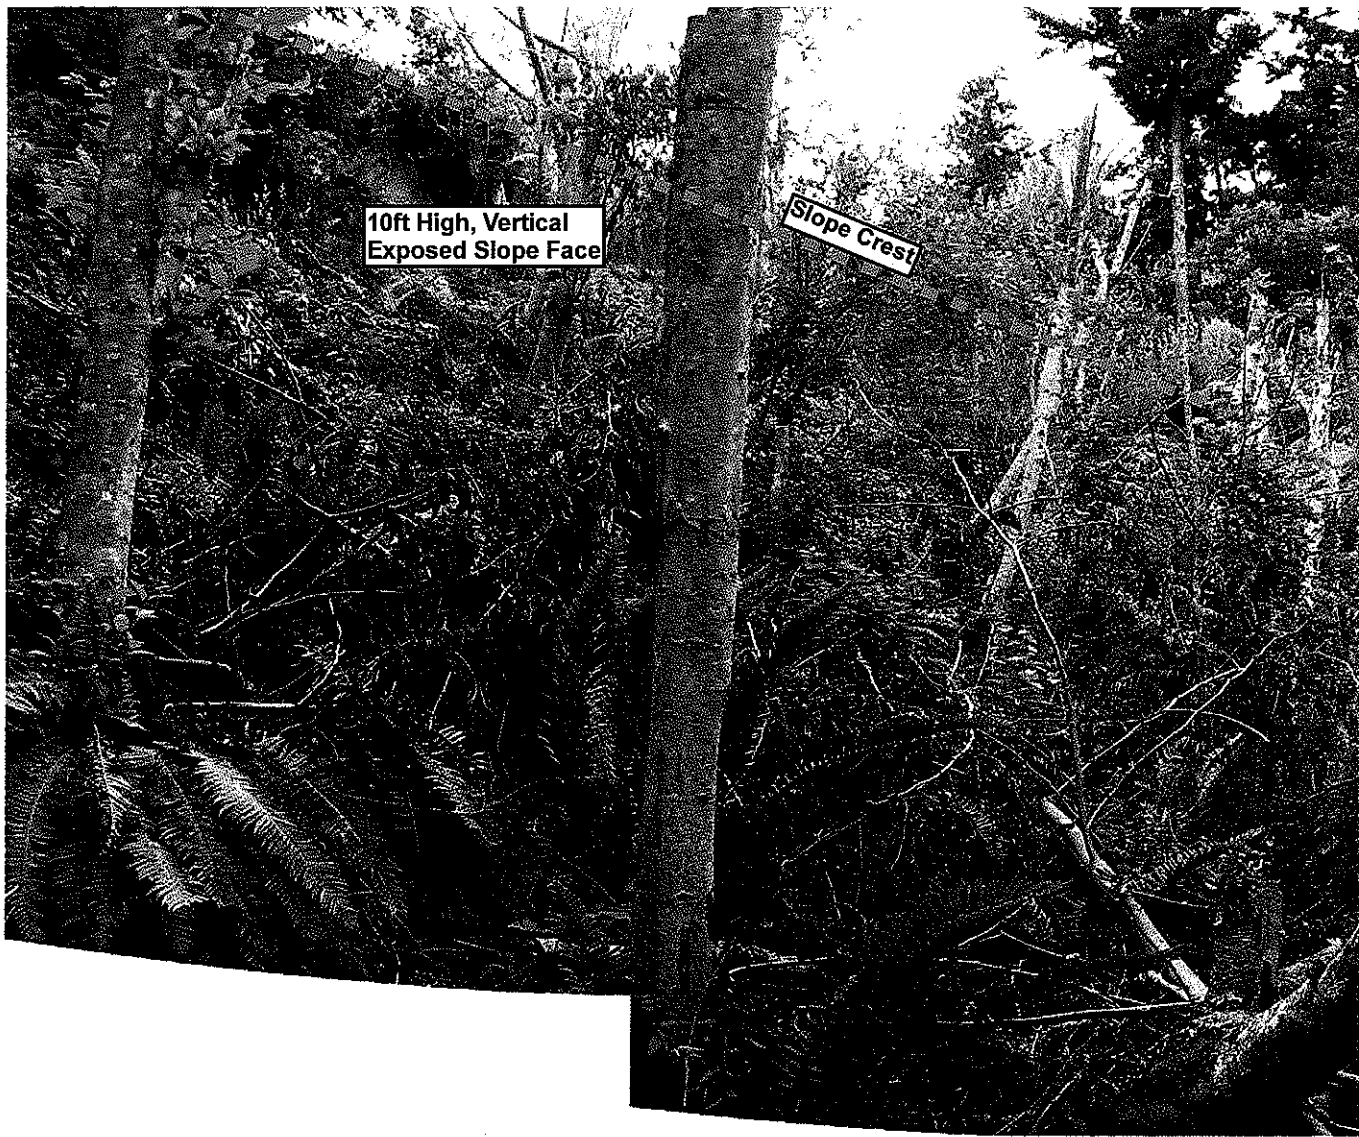
a. Slope crest profile below #234, #240 and #260 showing recent clear-cut area. View looking northwest. August 18

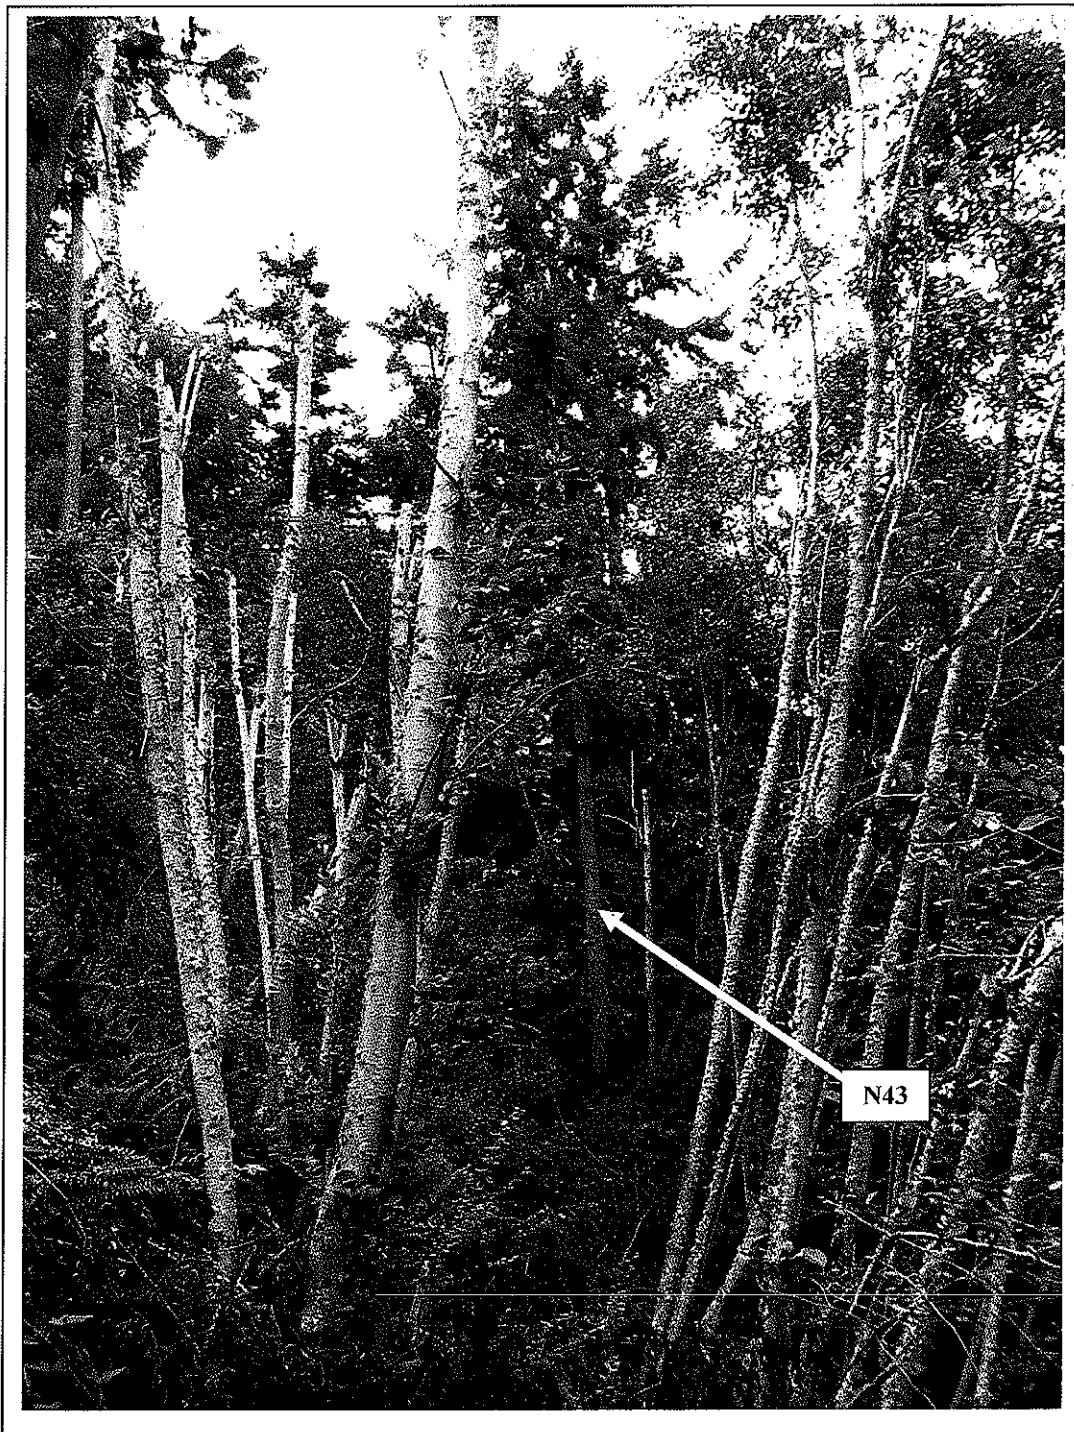
This tree is located along the edge of the northern sector boundary with Old Fort Townsend State Park, directly below house #260, at about 80 ft (Elevation 110 ft) below the slope crest. This straight-trunked tree (approximately 24-inch DBH), is located within an evenly sloped portion of the slope. It is protected to the north by a forest of mature deciduous trees and surrounded by a light understory of brush. The south side of N43 and across the slope for about 100 ft is predominately vegetated with 6- to 12-inch DBH alders that were severely limbed and topped earlier this year (Figure 5). This tree limbing/topping zone extends from the crest of slope downslope about 100 ft (Elevation 80 ft). The alders in this area generally lean downslope at angles ranging from about 20 to 25 degrees. This leaning characteristic is typical for alders growing on slopes.

Alders dominate this area and are typically the first species to colonize rapidly in a disturbed area. Alders are prolific but short-lived (about 80-100 years). The slope surface within this zone is hummocky, loose underfoot, and reclined at an angle of about 40 degrees. A near vertical, 10-ft high scarp feature was observed to extend along the crest for a distance of at least 100 ft. The understory within this open area consists of sword-fern and light brush. Debris from the recent tree cuttings remains on slope. No groundwater was observed; however, two corrugated, 12-inch diameter drainage pipes were observed extending from the crest to unknown discharge points downslope (Figure 3). It appears that this area, located adjacent to and south of N43 appears to have experienced landslide activities in the past, (pre-2000 based on LiDAR imagery - see Figure 3). The age of the feature is unknown and it cannot be seen in a review of available aerial photographs. The likely effect of this recent tree cutting activity will be to accelerate the downslope movement of loose soils. It appears that previously eroded soils from this feature have migrated downslope, partially accumulating mid-slope behind a large stand of mature alders, before sloughing onto the beach below. Occasionally, soil debris is transported through this stand onto an open and bare scarp that extends to the beach below. This is the only toe area along the northern sector that slide debris obscures the vertical glacial lacustrine clay along the toe which indicates that wave action has not yet removed the slide mass and as such indicates recent slide activity.

a. Located along the northern boundary below #260.

- All disturbed bare areas created during tree cutting, including newly opened canopy areas that will be created in cutting N43 and N47, should be re-planted with suitable native species. Without proper management, some brush species thrive and flourish when a tree overstory is removed, creating a view management problem. This is particularly true for species such as oceanspray, and salmonberry which can grow up to about 12 ft high and elderberry which can reach heights of 20 ft. Alders will flourish, but repeated cutting of alders increases their mortality rate. Another species encouraged by increased light levels is Himalayan blackberry which is difficult to control. Future long-term slope erosion, especially the upper 10 to 15 ft directly below houses #234, #240, and #260 with exposed vertical scarps, should be mitigated by planting select, native, low-lying, drought-tolerant vegetation for a range of soil and light conditions. Salal, Evergreen huckleberry, and Oregon grape are all valuable native species that supply wildlife habitat, erosion control benefits, and are easily maintained. Species such as sword fern, snowberry, and red huckleberry are also valuable native species that are more adaptive and able to survive environmental modifications. A qualified landscape architect should be selected to choose the appropriate plants for the site conditions and plant them along the slope crest accordingly. The Washington State Department of Ecology discusses coastal bluff planting and appropriate site maintenance practices on its website (<http://www.ecy.wa.gov/programs/sea/pubs/93-31/intro.html>).

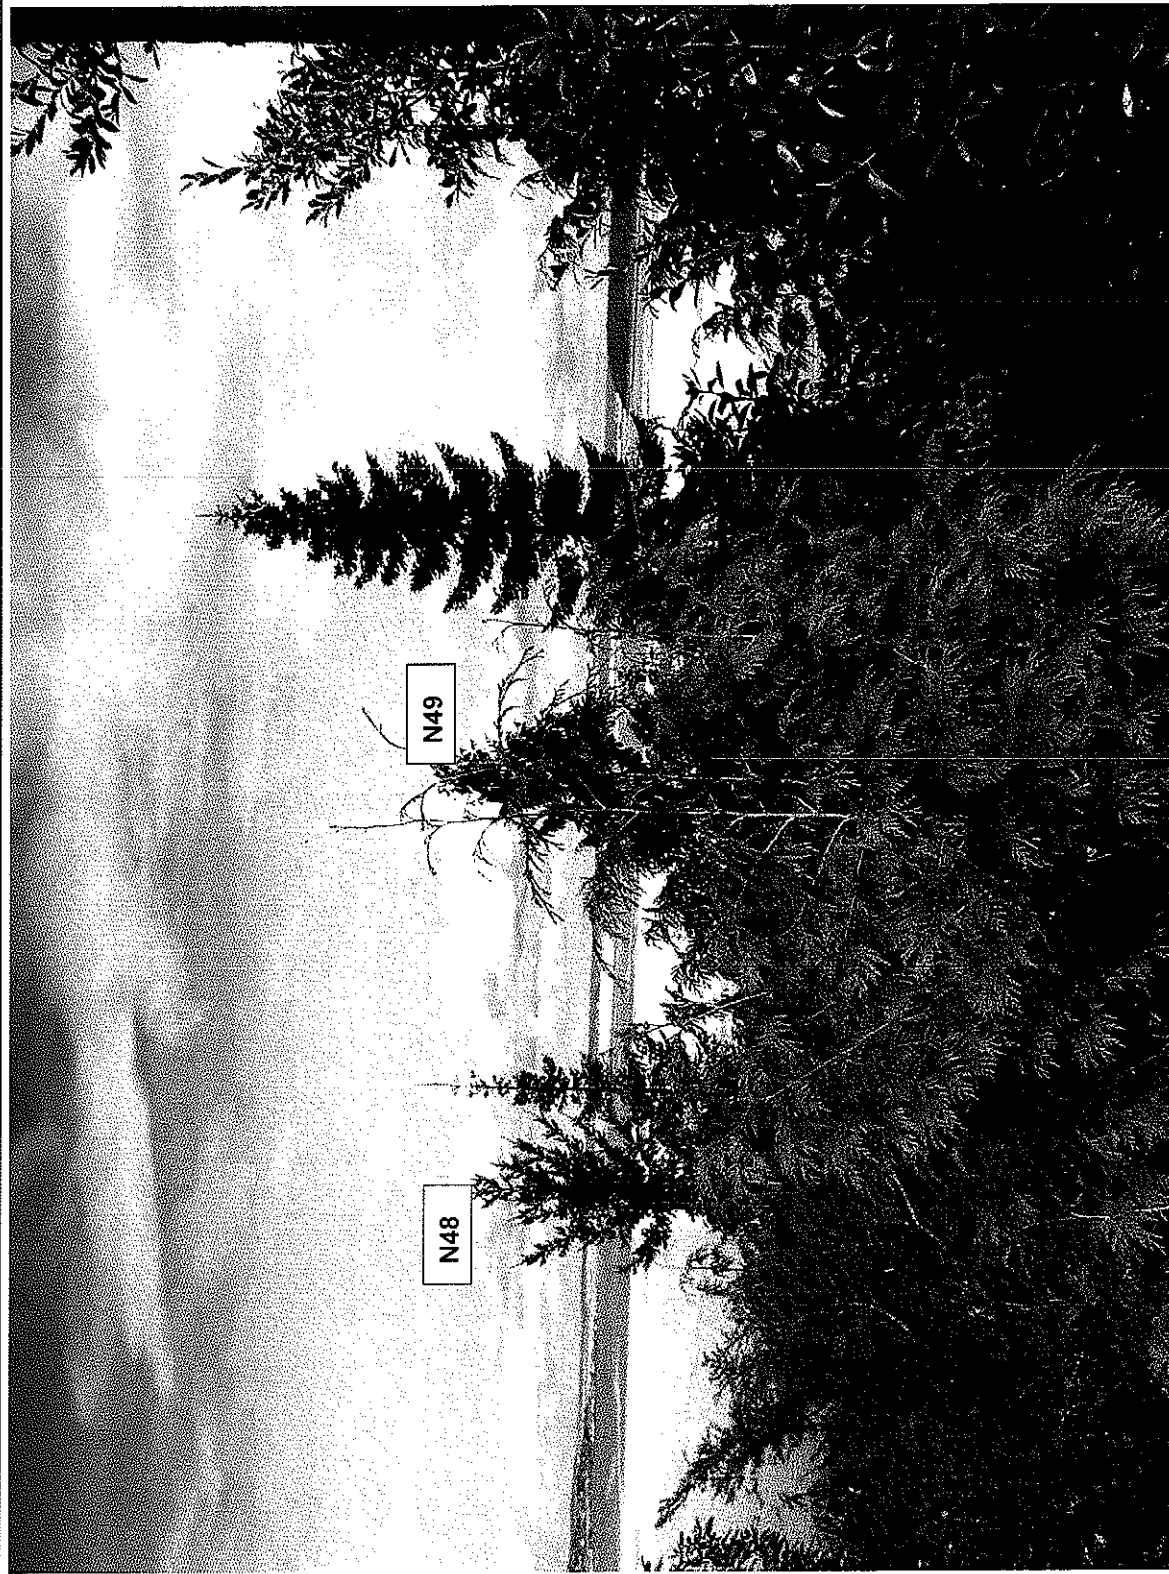
Figure  
10

This fir tree is located about 25 ft (Elevation 145 ft) below the slope crest of house #110 (Figure 10). This straight-trunked, 12-inch DBH fir tree is located within an evenly sloped area, surrounded by other fir trees with equal DBH diameters including 4-inch DBH madrona trees (Figure 11). Adjacent to this tree is a cedar tree stump, anecdotal information from BMAC indicates that this was cut in 2006. The general area has a moderate to dense understory of brush. No active springs or seeps, or indications of recent slope instability were observed in the general area.

This cedar tree is located about 35 ft (Elevation 135 ft) below the slope crest of house #110 (Figure 10). This 12-inch DBH tree exhibits a slight downslope curvature at its base and is located above and adjacent to a group of 4-inch DBH madrona trees and 12+ DBH fir trees (Figure 11). Several cut stumps surround the general area; anecdotal information from BMAC indicates that these were cut in 2006. The general area has a moderate to dense understory of brush. Upslope of this tree location at least two 8- to 10-inch high Pacific Yew saplings were observed, anecdotal information from BMAC indicates that these were planted in 2006. No active springs or seeps, or indications of recent slope instability were observed in the general area.

Site Photograph  
Select Trees N48/N49
