September 1, 2010

**RE: GEOLOGIC RECONNAISSANCE LETTER REPORT**  
**KALA POINT BLUFF (NORTHERN SECTOR)**  
**PORT TOWNSEND, WASHINGTON**

Geologic Reconnaissance  
Kala Point Bluff  
(Northern Sector)  
Port Townsend, Washington

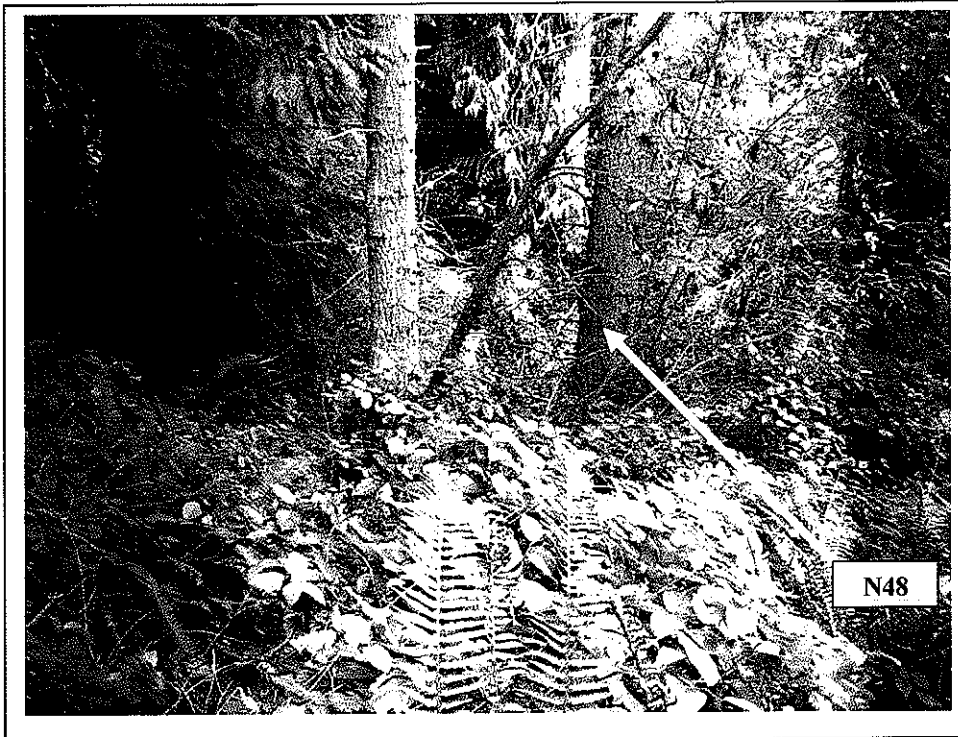
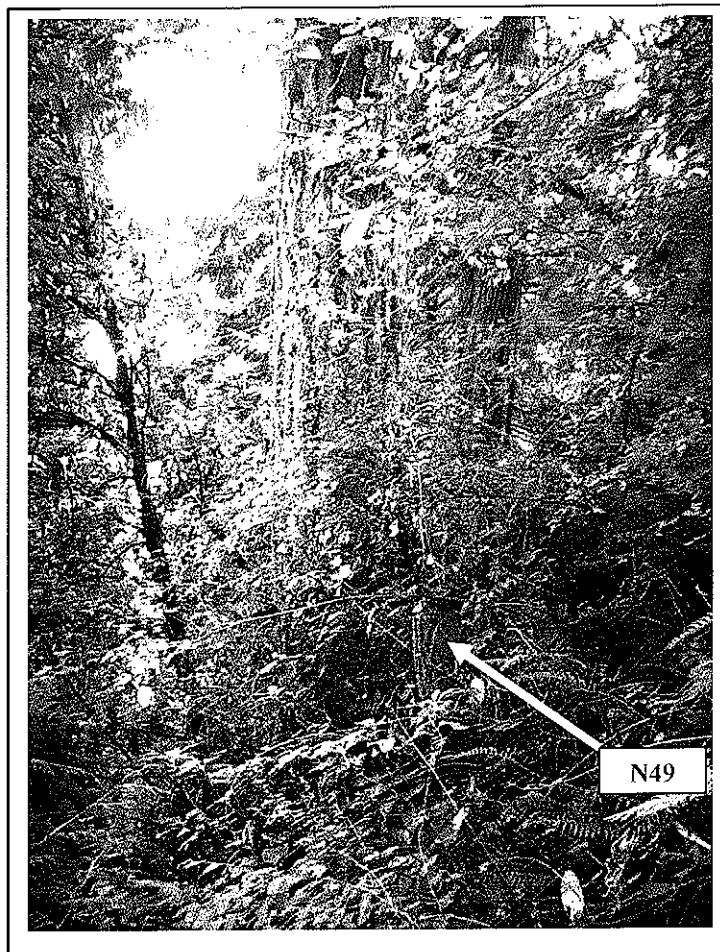
This fir tree is located about 25 ft (Elevation 145 ft) below the slope crest of house #110 (Figure 10). This straight-trunked, 12-inch DBH fir tree is located within an evenly sloped area, surrounded by other fir trees with equal DBH diameters including 4-inch DBH madrona trees (Figure 11). Adjacent to this tree is a cedar tree stump, anecdotal information from BMAC indicates that this was cut in 2006. The general area has a moderate to dense understory of brush. No active springs or seeps, or indications of recent slope instability were observed in the general area.

This cedar tree is located about 35 ft (Elevation 135 ft) below the slope crest of house #110 (Figure 10). This 12-inch DBH tree exhibits a slight downslope curvature at its base and is located above and adjacent to a group of 4-inch DBH madrona trees and 12+ DBH fir trees (Figure 11). Several cut stumps surround the general area; anecdotal information from BMAC indicates that these were cut in 2006. The general area has a moderate to dense understory of brush. Upslope of this tree location at least two 8- to 10-inch high Pacific Yew saplings were observed, anecdotal information from BMAC indicates that these were planted in 2006. No active springs or seeps, or indications of recent slope instability were observed in the general area.
